Solwara 1 Project

Volume A
Main Report

Figures and Plates

VOLUME A: MAIN REPORT FIGURES AND PLATES

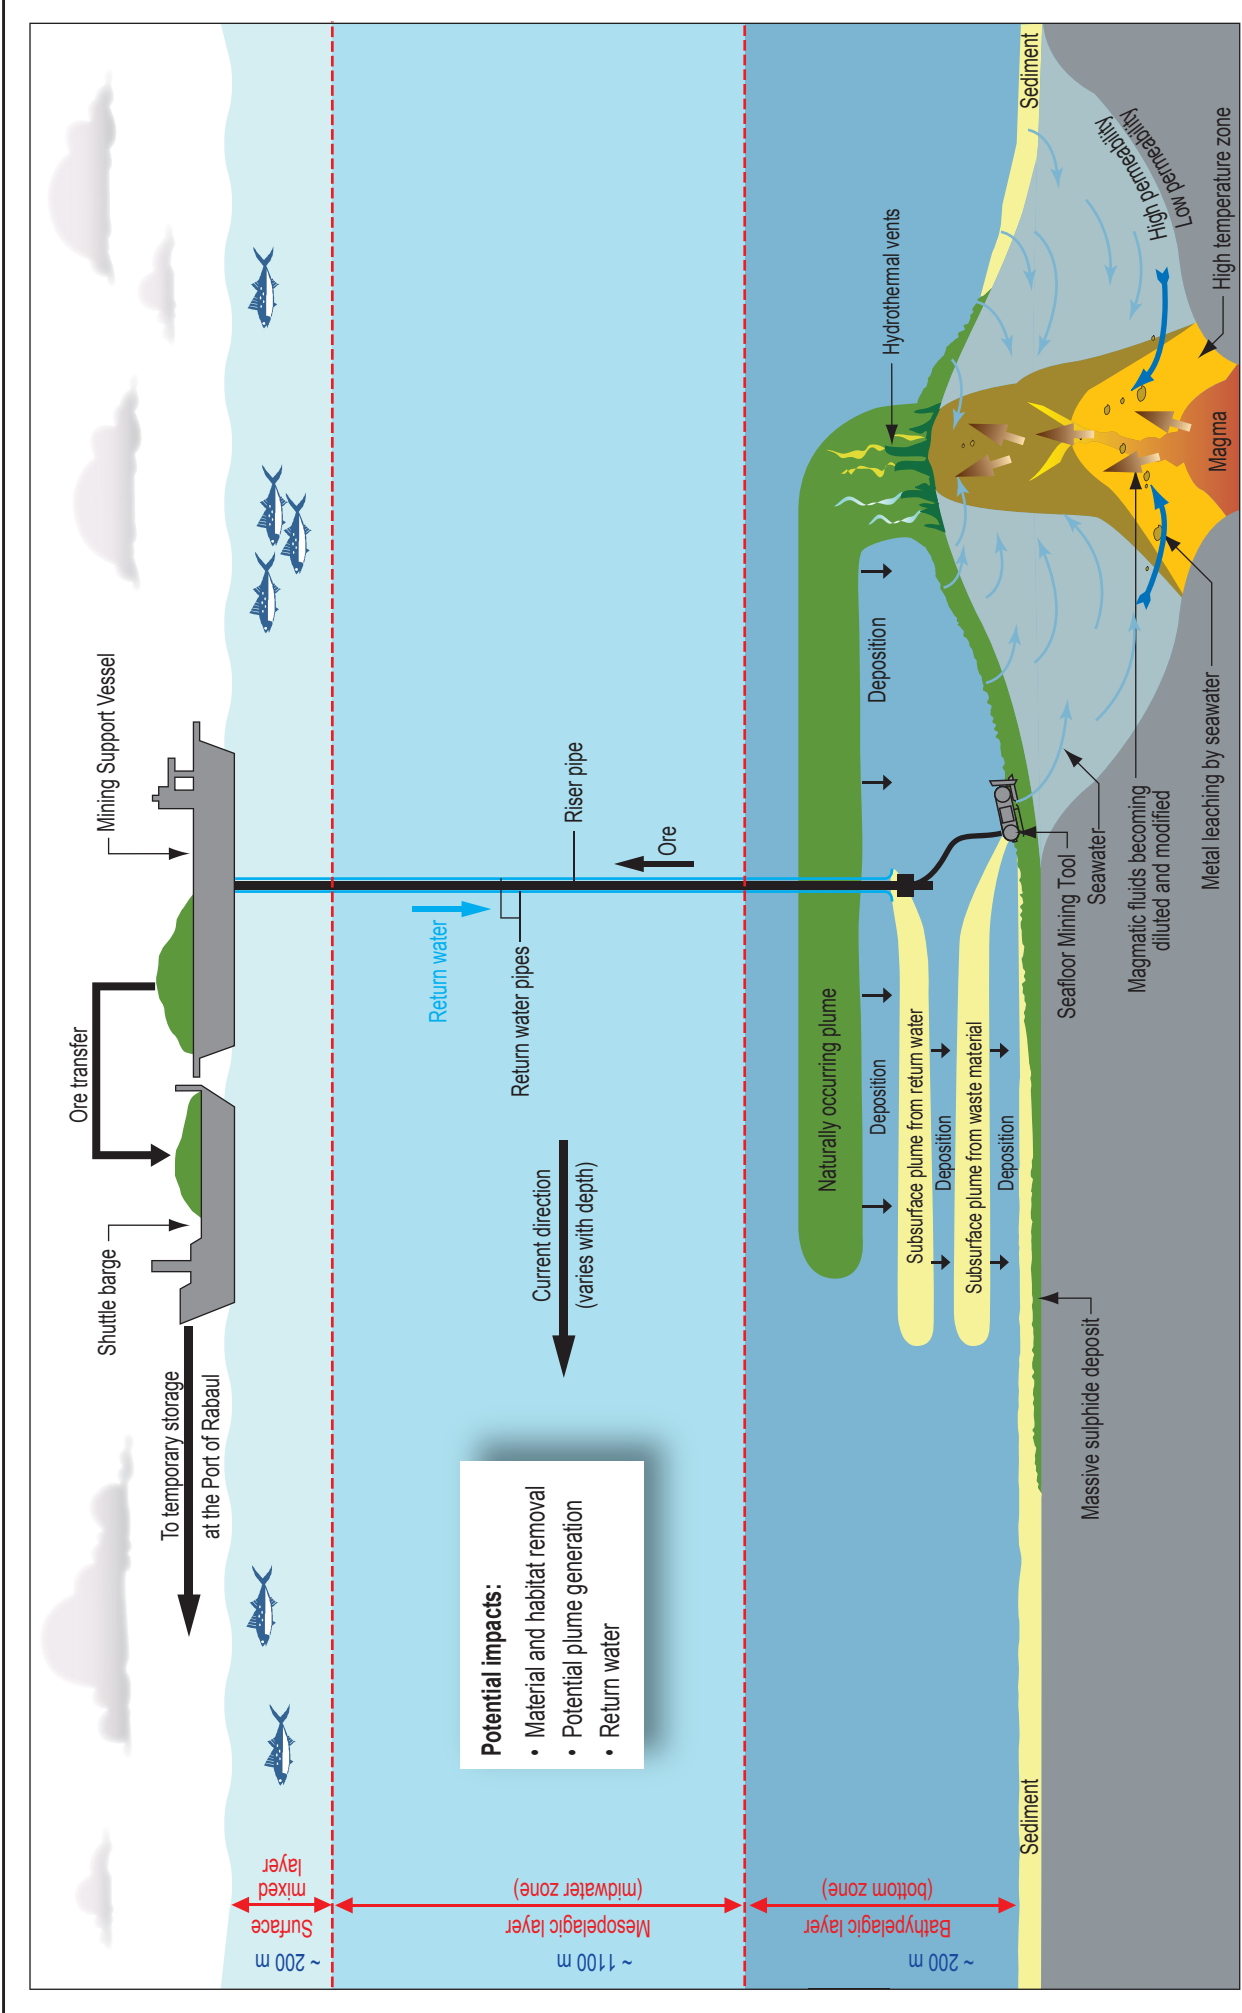
Potential impacts:

- Material and habitat removal
- Potential plume generation
- Return water

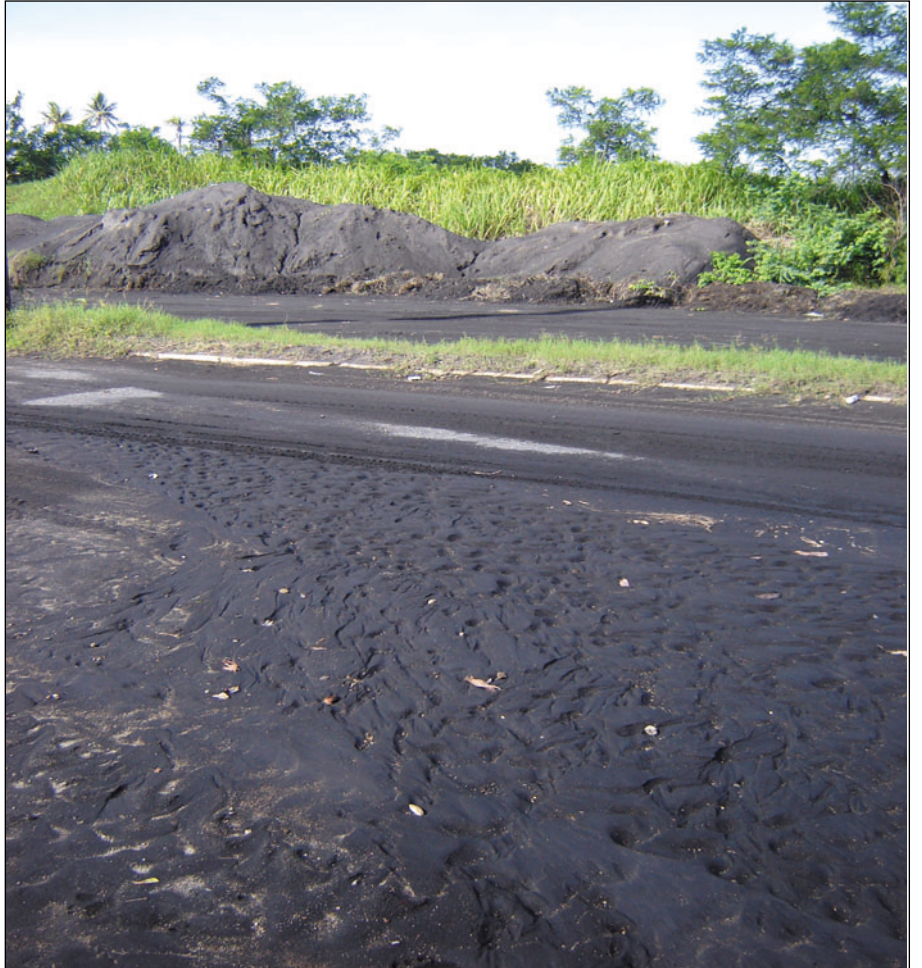
Plate 11.1
Ash accumulation on the road
in front of Rabaul Hotel,
29 December 2006

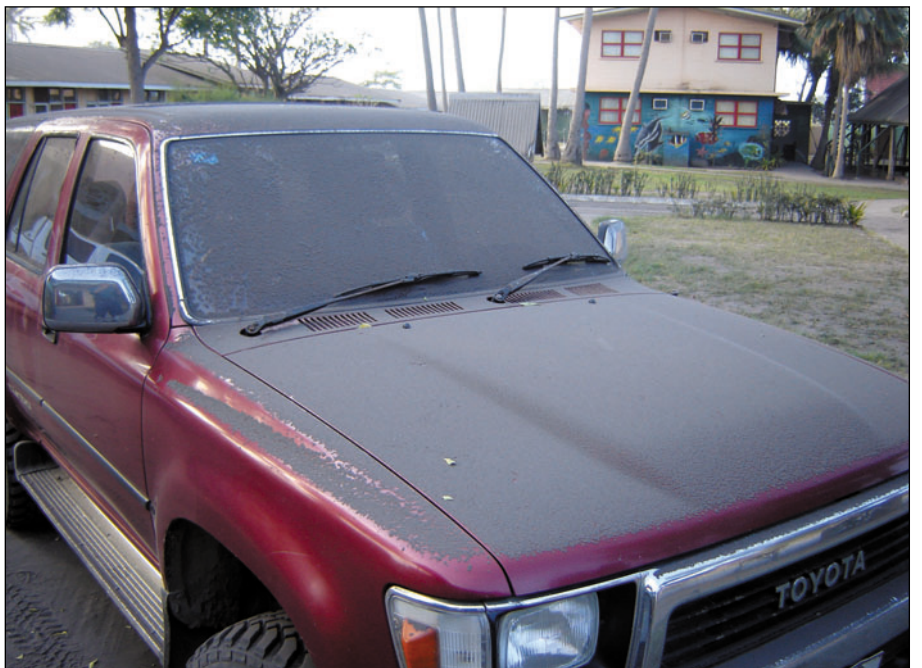
Plate 11.2
Overnight ash accumulation on
a vehicle at Rabaul Hotel,
27 October 2006
